Test report Ovet B.V. - Crane 8

The field-test took place on Ovet Crane 8, a floating lemniscate crane intended for the distribution of large bulk loads in North Sea Ports. Ovet B.V. has 4 floating lemniscate cranes in operation.

Test report Ovet B.V. - Crane 8 – October 2019

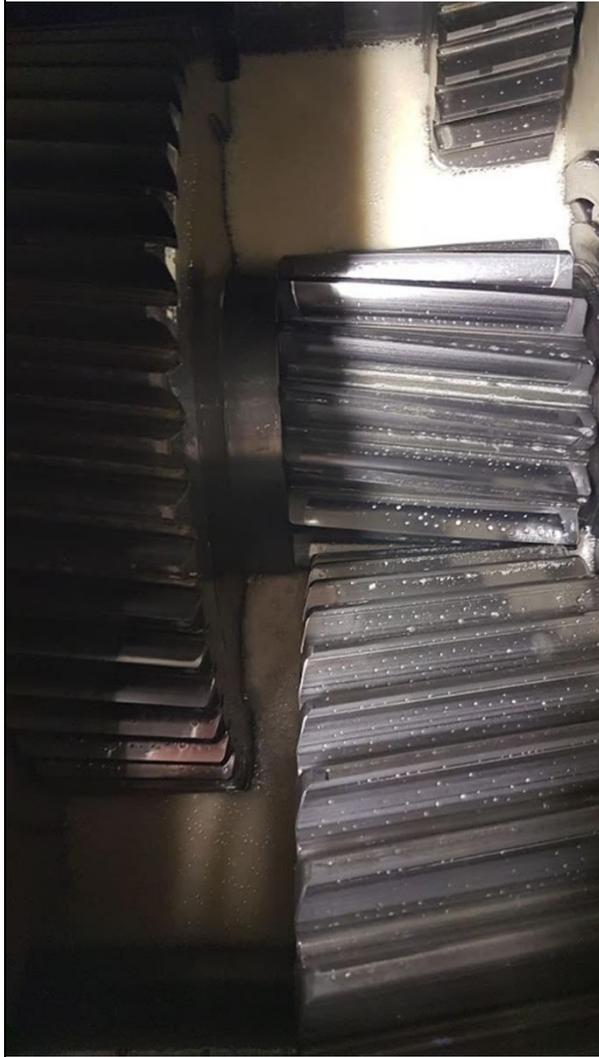
Foam – (Major X) ISO VG 320 – Gearbox (Closing gearbox)

4. The 3rd analysis on 29-08-2019, an oil sample has been taken again from both gearboxes. Again, at operating temperature, strong foam formation was noticed in the Major X gearbox and not in the DEX gearbox. *(See images in the appendix).*

- **Foaming oil** is caused by air intake of spinning gears. That air separates itself slowly from the oil. The compressed gases cause enormous temperature increases. Resulting in high oxidation of the oil which can cause varnish. Often, in non-stable base oils, a strong tendency to develop varnish is shown. Foam also has a strong negative influence because cavitation occurs.

Gear Oil: (Major X) ISO VG 320
In real-time Ovet Crane No 8.
Visual inspection: 29-08-2019

Make: Thyssen
Type: NK SDN 450 SO/S
Sn: 8 8252 5 1132/53016
KW: 300
N1/N2 rpm 1000/40

Content: 205L
Hours: 526
Average Temp: 52.5 °C

This laboratory result indicated that the DEX DP2 ISO VG100 lifting gearbox now had a value of 5 (Fe) and the (Major X) ISO VG320 gearbox has a value of 16 (Fe). The resin formation in the (Major X) ISO VG320 gearbox appears to have increased and it is advised to apply a resin cleaning or replace the oil.

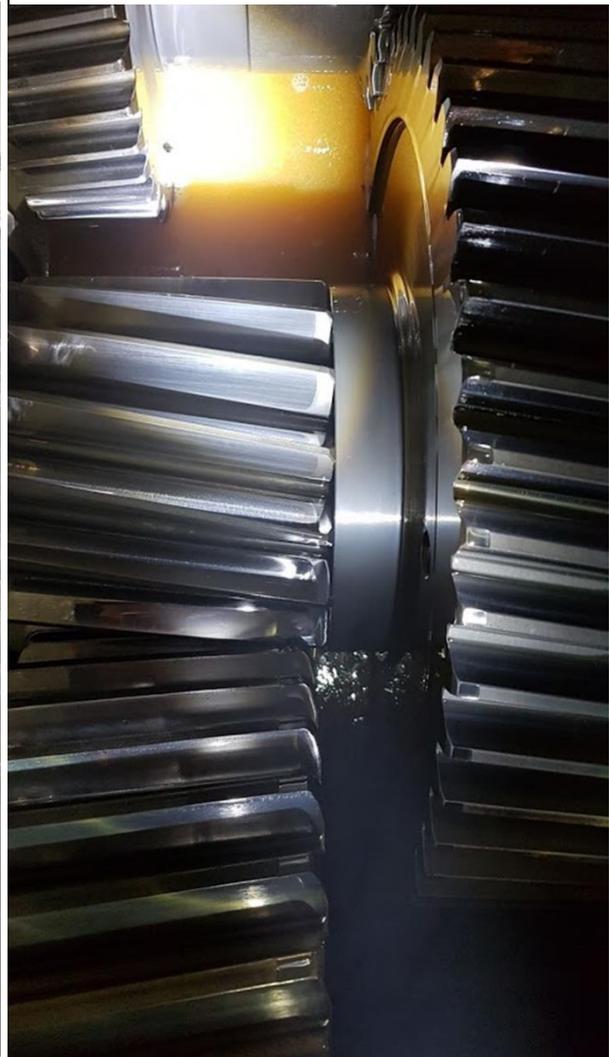
No foam – DEX DP2 ISO VG 100 – Gearbox (Lifting gearbox)

DEX DP2 ISO VG100 has an extremely good gas discharge and is very oxidation-and viscosity stable. The DEX DP2 ISO VG100 is therefore not foaming. (See images in the appendix)

Gear Oil: DEX DP2 ISO VG 100
In real-time Ovet Crane No. 8.
Visual inspection: 29-08-2019

Make: Thyssen
Type: NK SDN 450 SO/S
Sn: 8 8252 5 1132/5301
KW: 300
N1/N2 rpm 1000/40

Content: 205L
Hours: 500
Average Temp: 48.2 °C
